**Soil
Conservation
Service**

FLOODPLAIN MANAGEMENT STUDY

CROSSVILLE WHITE COUNTY ILLINOIS

JUNE 1984

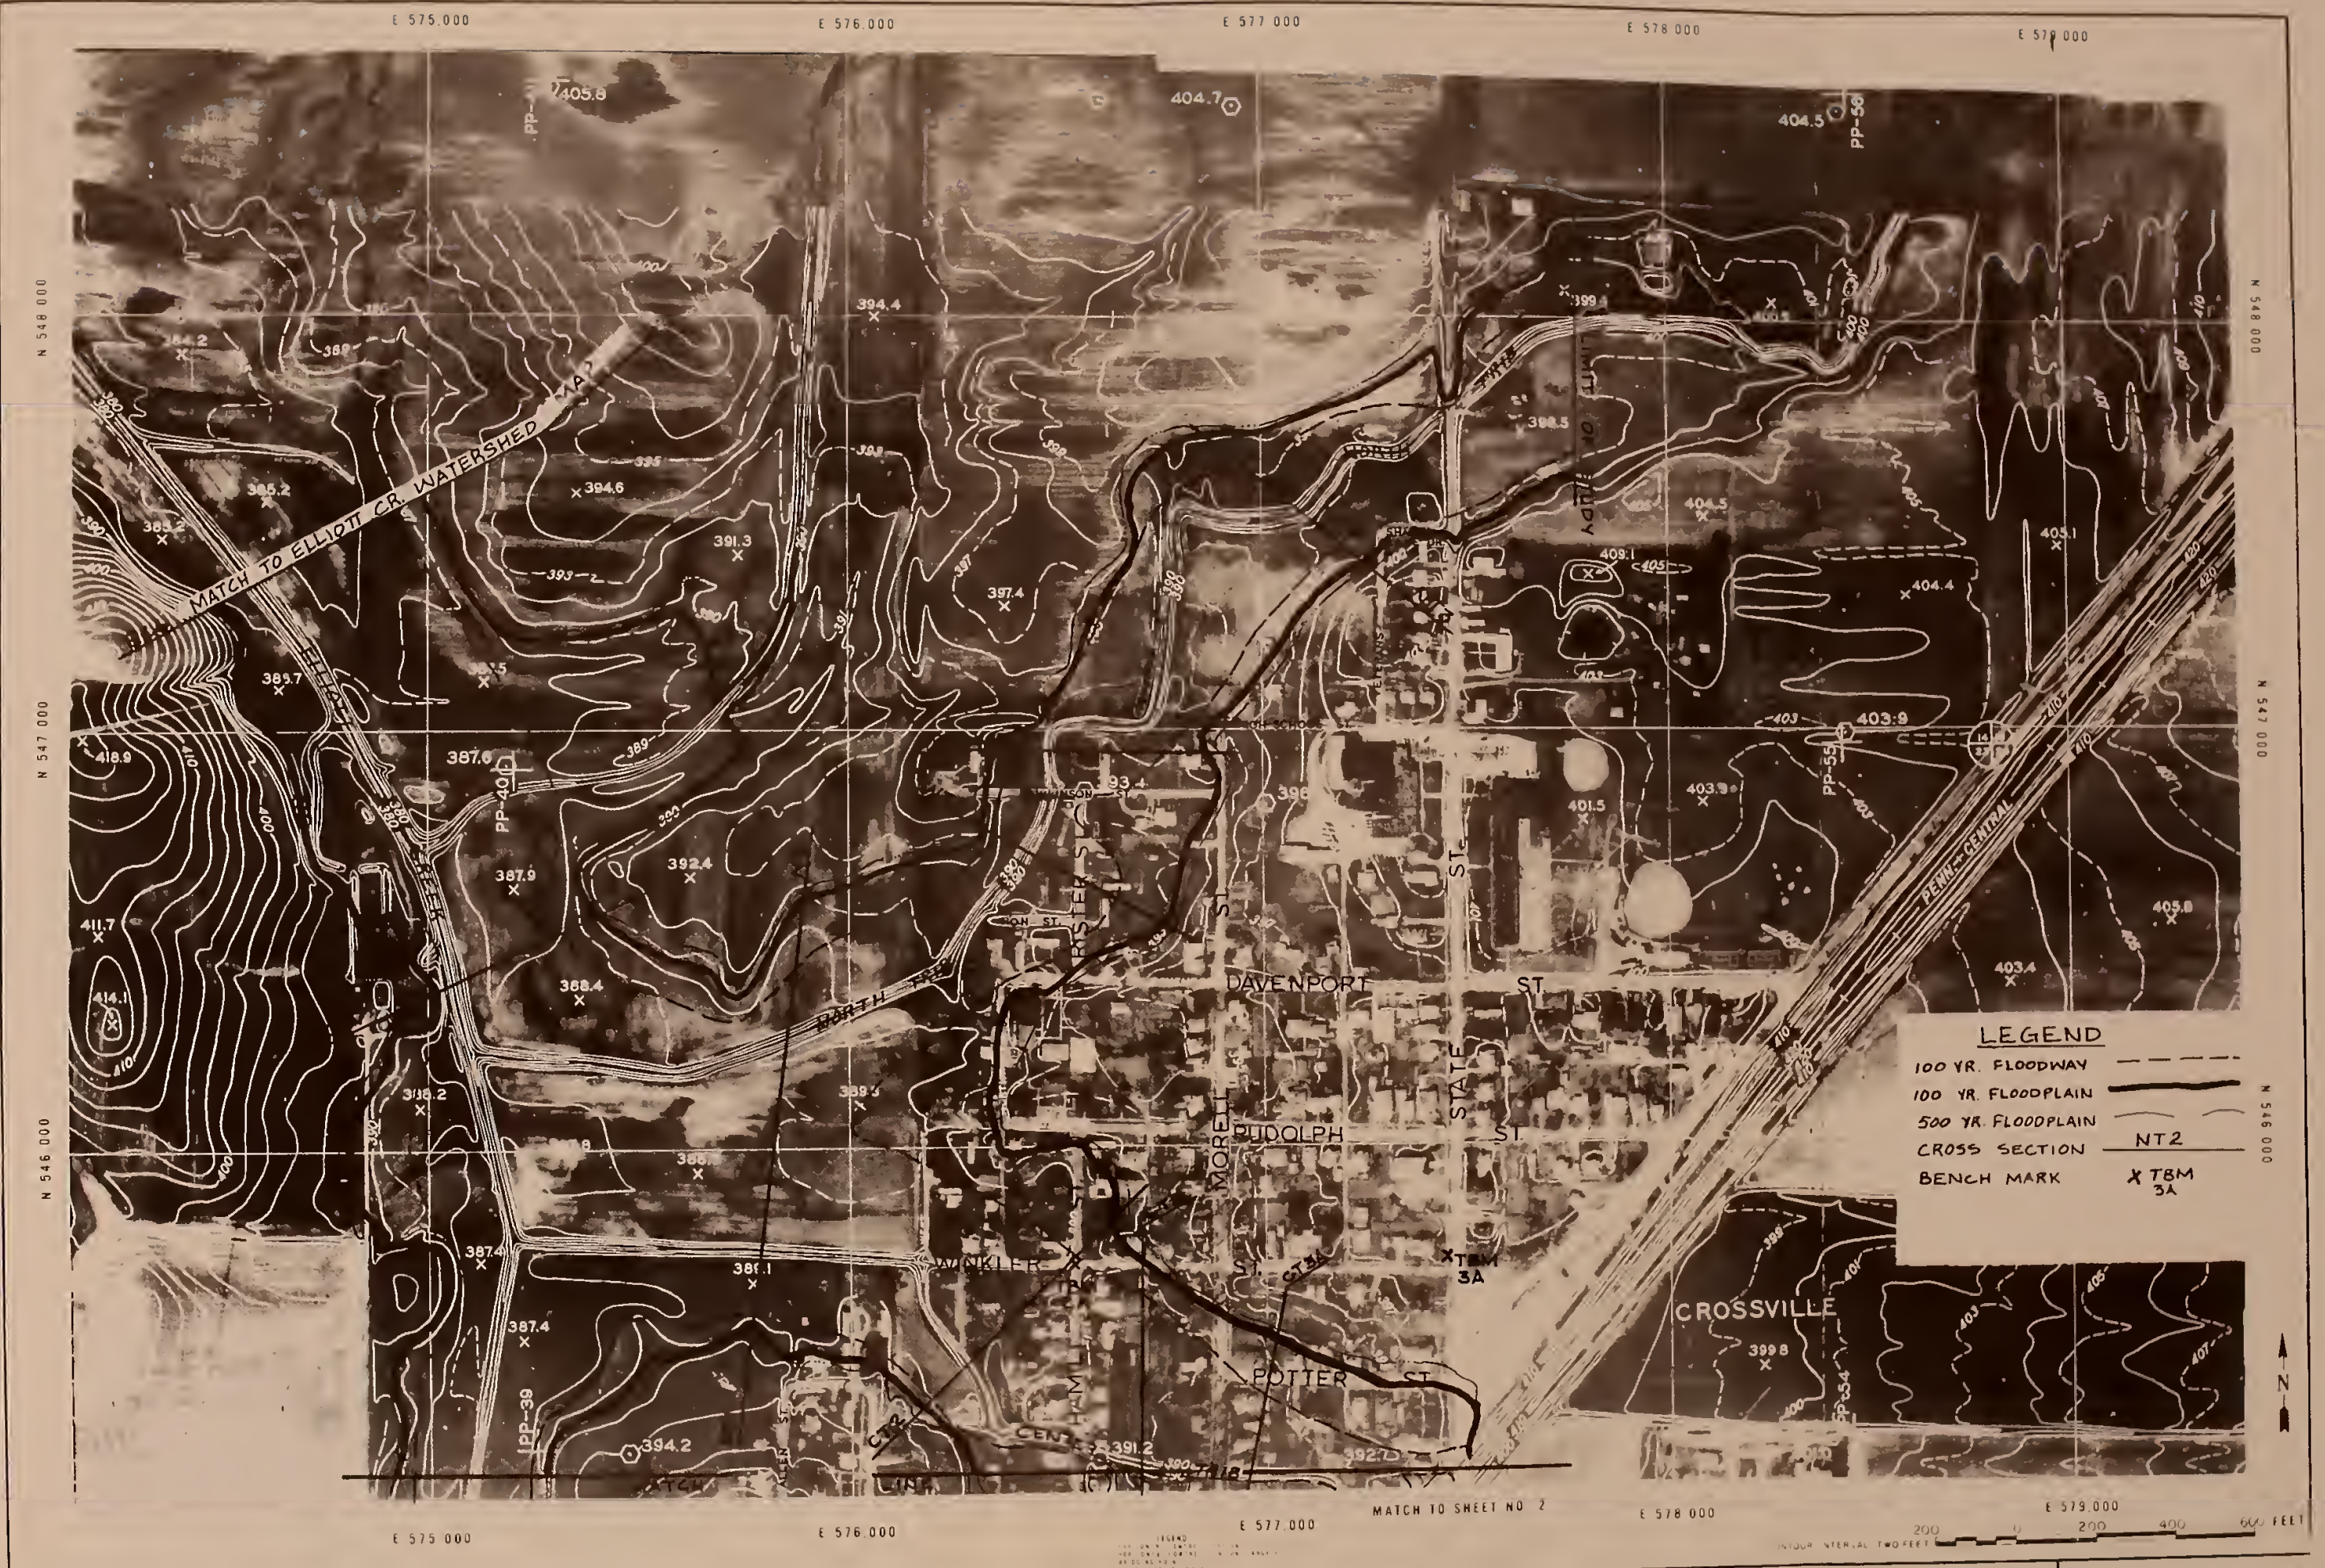
As shown on the flood boundary and floodway maps in Figures 4 and 5, the floodway boundaries were determined at individual cross sections. Between the cross sections the boundaries are interpolated.
